### Inspection & Remedial Proposal of Damaged Bridge Girder

Zekreet Bridge,  
Zekreet - Qatar

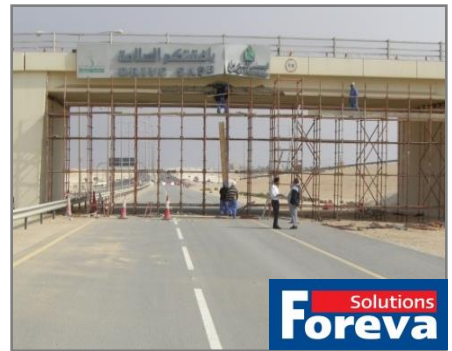
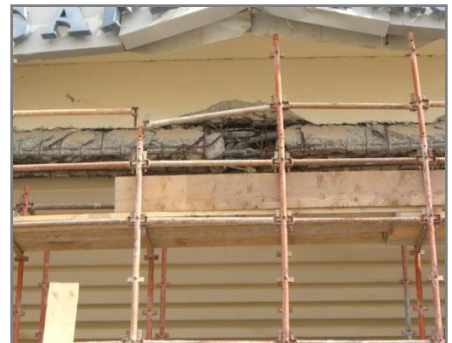
The beam was hit by an excavator loaded on a trailer on its way to Doha. The adjacent inner girder is unaffected & intact.

The girder was damaged at the mid span where the tendons are located at the lowest point. The three tendons were damaged, exposing the strands to corrosion activity.

Thorough site investigation, relevant structural integrity computations and checking were done. Freyssinet has successfully identified and proposed the required remedial actions and procedures for the affected girder.
