Repairs

Bridge Jacking Works for Replacement of damaged PTFE Sheets

Al Garhoud Bridge
Dubai - UAE

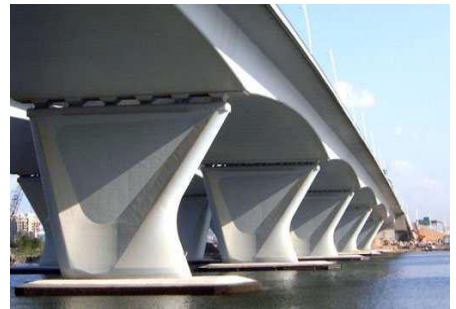
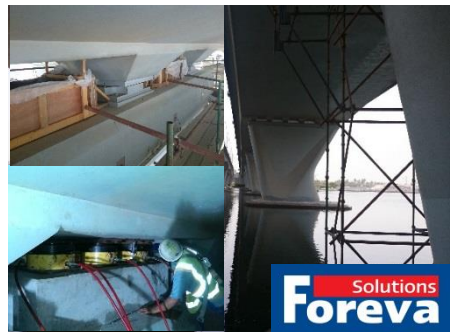
On Pier 1 of Al Garhoud Bridge in Dubai, PTFE layer sheets on guided pot bearing type D* were damaged and had to be replaced. Due to the fact that PTFE sheets are creeping in longitudinal guided pot bearing on the Pier 1 east side, repairing work was performed in one pier only and structure was lifted only from that pier.

Freyssinet was appointed for design, supply and execution of bridge jacking works and replacement of damaged PTFE sheets (1000mm Ø, 4.5mm thickness) by means of 36 nos. of 520 tons capacity of hydraulic jacks.

The full activity on site was completed within 5 days, without any interruption of the heavy traffic, respecting the project health and safety requirements.
