## Repairs

### Sohar Copper Refinery Sohar, Oman

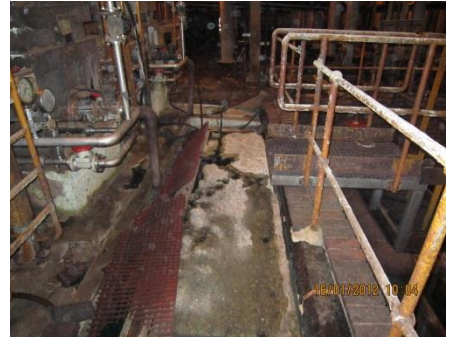
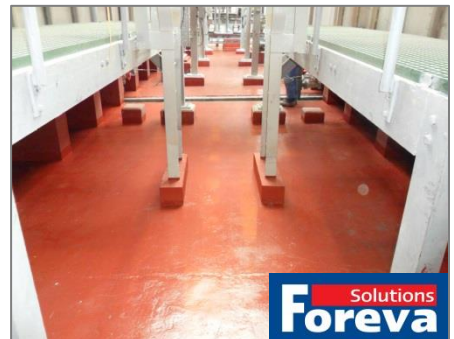
The refinery had suffered severe deterioration to the concrete resulting in.

1. Concrete erosion;
2. Deterioration of drain channel thus acid leakage to sub soil;
3. The acid reaction with the soil resulted in expansion of rock-bed under the basement and cell tanks caused an expansion to it. This expansion produced stresses underneath the structure, which resulted in elevation of cell supporting system thus effecting the levels.

Freyssinet proposed temporary remedial action which is based on.

1. Bring the cell tanks to operational stage through lifting.
2. Complete reinstatement of basement slab, drain channel, sump tank and all concrete pedestals .
