Repairs

Strengthening of Third Floor Slab Due to Additional Loading

Nation Towers

Abu Dhabi - UAE

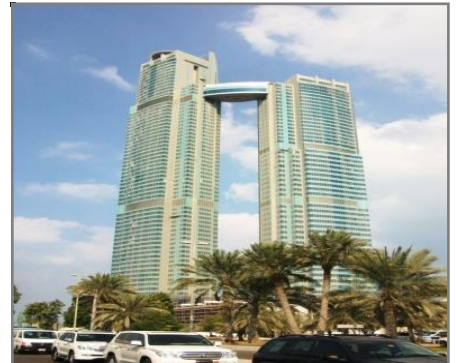
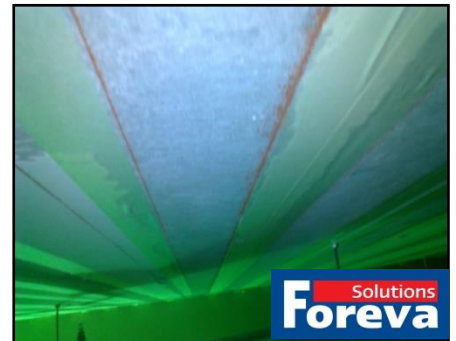
Client requested the possibility of introducing a Jacuzzi to third floor post-tension slab resulting in having a additional load that was not accounted for in the design stage.

Freyssinet made a complete analysis and found that client request can be meet through strengthening with CFRP reinforcement to accommodate the new load imposed to the slab.

The application of the technical solution and slab cut, CFRP reinforcement installation as per the design requirement.
