Repairs

Deck lifting and Elastomeric Bearings Replacement
Nesma Headquarters Offices
Building 2
Jeddah, KSA

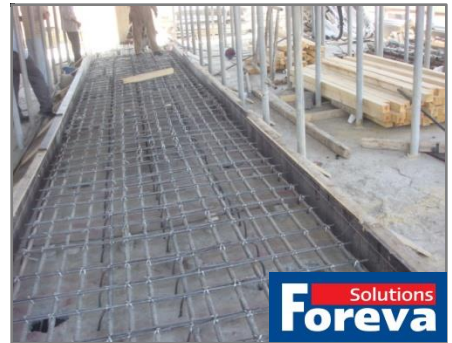
The slabs in 6th and 7th floor had undergone excessive deflection resulted from under design.

- The measured deflection was approximately 160mm;
- Visual cracks were also observed at locations where the deflections were high;
- The client wanted to change use for these levels that resulted in having additional loads than already designed for.

Freyssinet was approached by the Contractor to carry-out design, supply, and execution of strengthening works.

Freyssinet had made all the design/structural assessments and proposed a solution for strengthening considering all the restraints (i.e., clear height, MEP and architectural requirements, etc.).

Freyssinet introduced a pre-stressed beam that changed the behavior of the slab through which the deflection datum has changed and the slab could now take the new desired load as per the new use.
